# **The Road Inventory of William L Finley National Wildlife Refuge Corvallis, OR**

Prepared By:  
Federal Highway Administration  
Central Federal Lands Highway Division  
February 2013

# William L Finley NWR - 13589

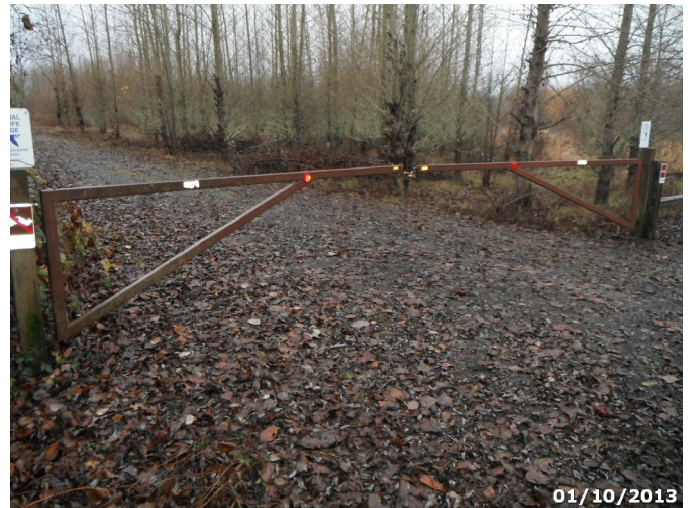
Photo: WIFI\_C4\_0433 Route: 407-001-0.0  
Metal Open Rail Gate

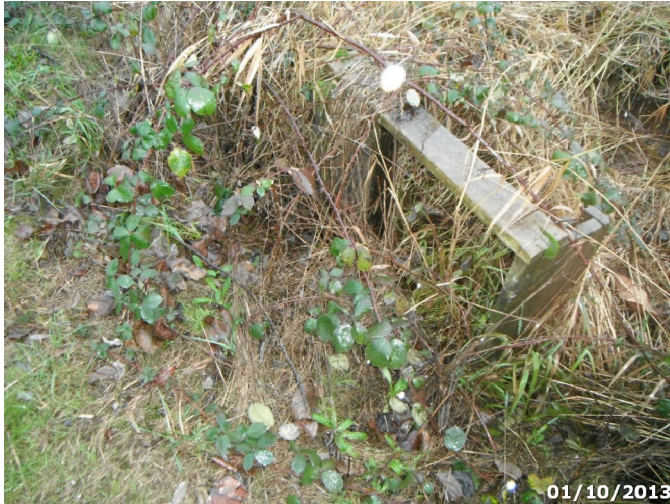
Photo: WIFI\_C4\_0434 Route: 407-001-0.09  
Concrete WCS Flashboard Riser  
25ft long 24in dia. 1ft deep

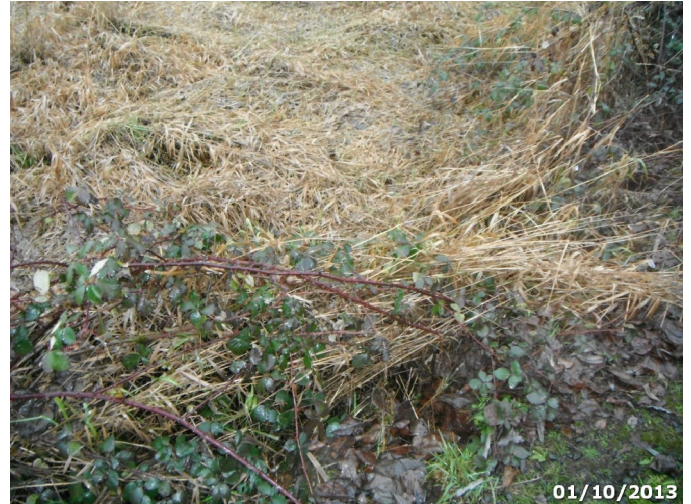
Photo: WIFI\_C4\_0435 Route: 407-001-0.09  
Concrete WCS Flashboard Riser  
25ft long 24in dia. 1ft deep

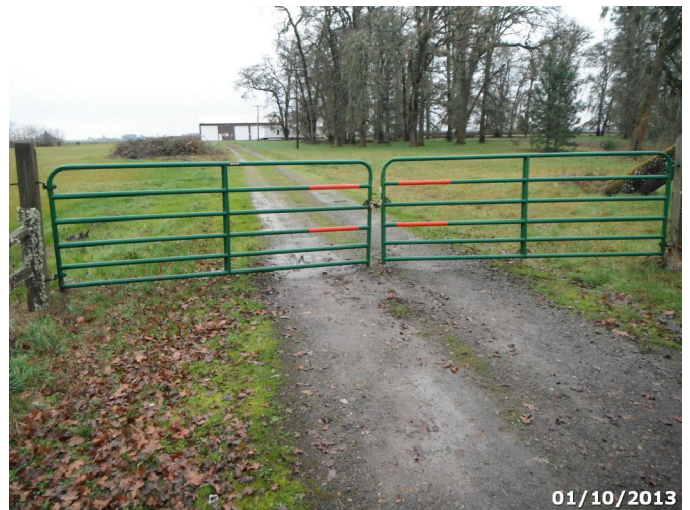
Photo: WIFI\_C4\_0440 Route: 408-001-0.01  
Metal Open Rail Gate

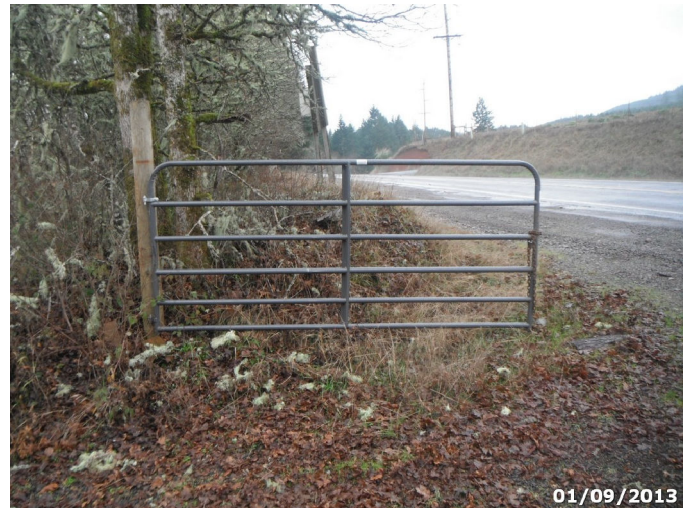
Photo: WIFI\_C4\_0263 Route: 409-001-0.0  
Metal Open Rail Gate

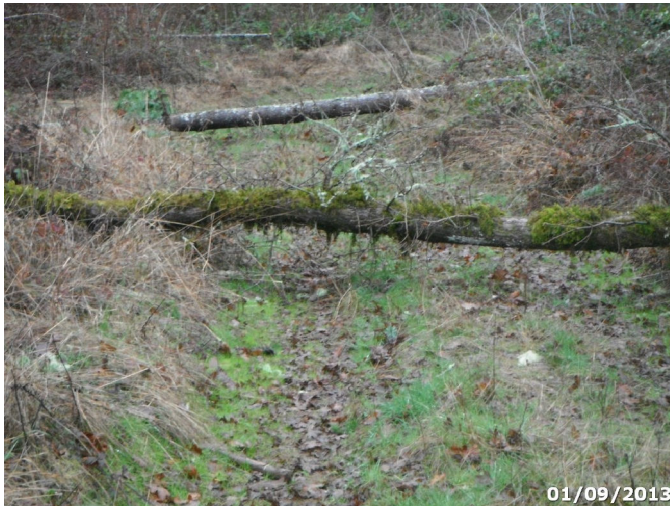
Photo: WIFI\_C4\_0264 Route: 409-001-0.07  
Problem Area Trees down

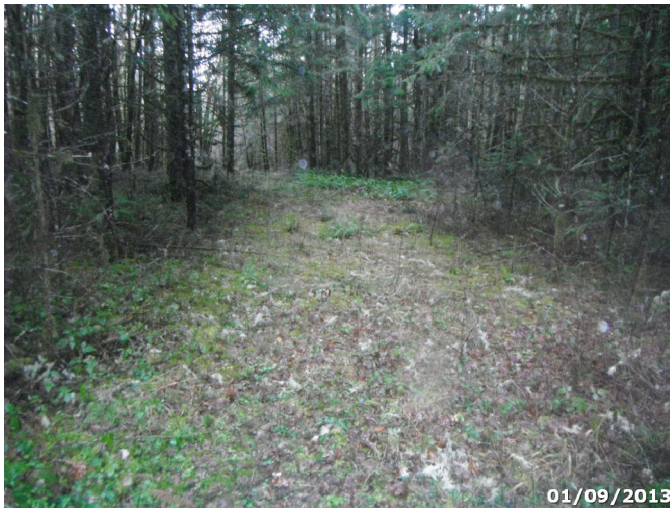
Photo: WIFI\_C4\_0260 Route: 600-001-0.0  
Problem Area  
Location of Mill Hill Prarie Access Road / Overgrown

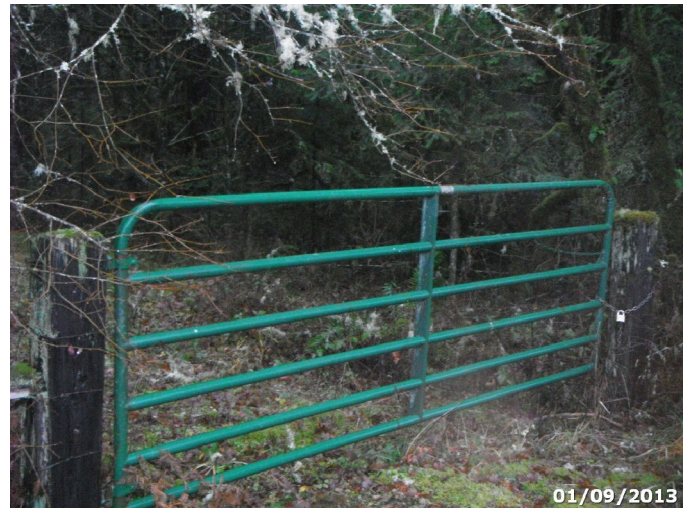
Photo: WIFI\_C4\_0261 Route: 600-001-0.0  
Metal Open Rail Gate

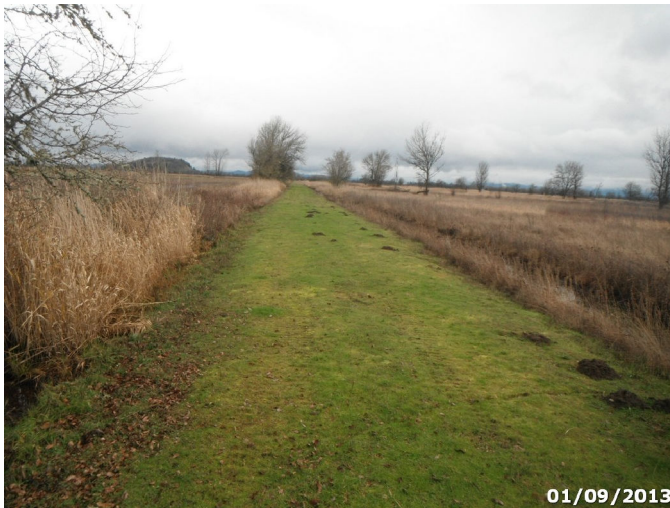
Photo: WIFI\_C4\_0274 Route: 602-001-0.0  
Obstacle Location of North Prairie Road  
Asset # 10048925/ too wet to drive

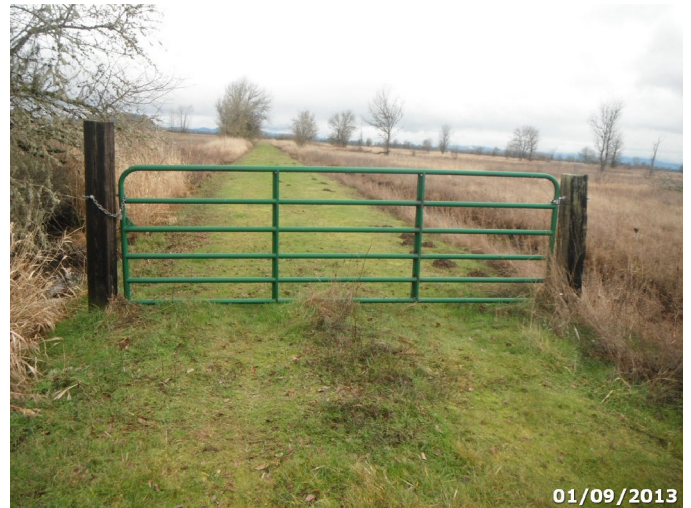
Photo: WIFI\_C4\_0275 Route: 602-001-0.0  
Metal Open Rail Gate

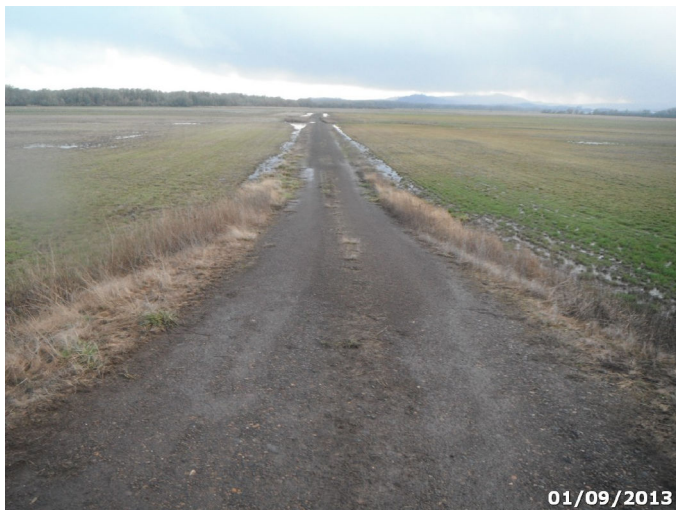
Photo: WIFI\_C4\_0405 Route: 603-001-0.0  
Obstacle Location of Field 12 Access Road  
Asset# 10064330/ road too wet to drive

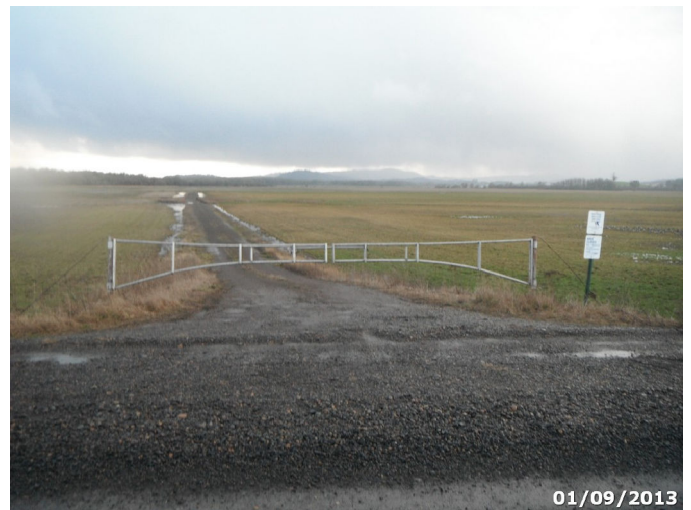
Photo: WIFI\_C4\_0404 Route: 603-001-0.0  
Metal Open Rail Gate

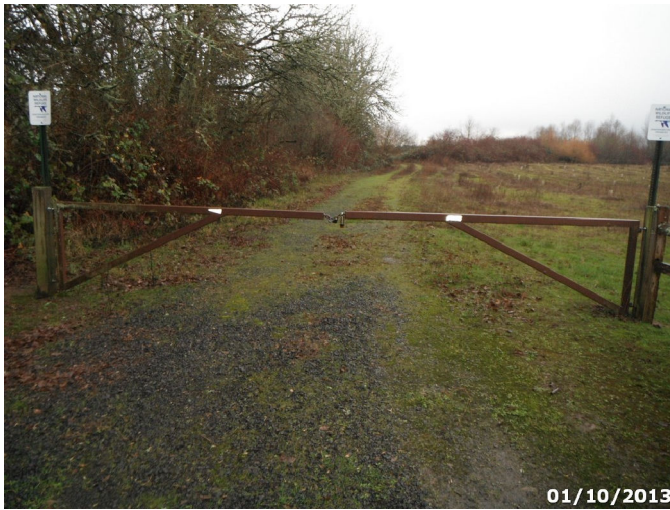
Photo: WIFI\_C4\_0431 Route: 919  
Metal Open Rail Gate
